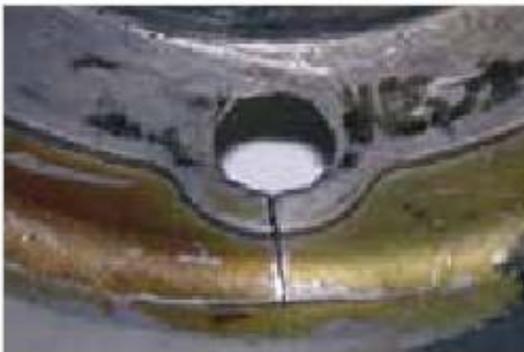
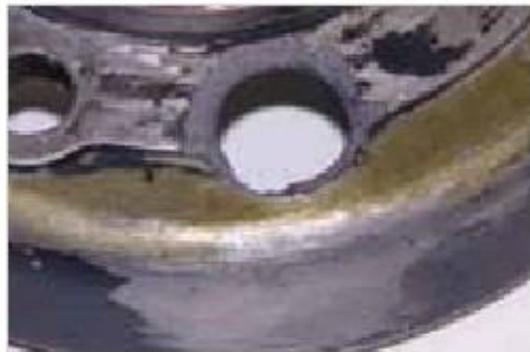
If the mounting screws to attracting fixed, it can lead to damage how come within the Kreismarking on image to see 6-139. For the the screw head countersunk area then breaks out of the case, as in Detail in the images 6-141 and 6-142 to see.

Figure 6-141: In Torn housing in the area of Reduction of the mounting screw due to an assembly error

Figure 6-142: In Torn housing in the area of Reduction of the mounting screw due to an assembly error

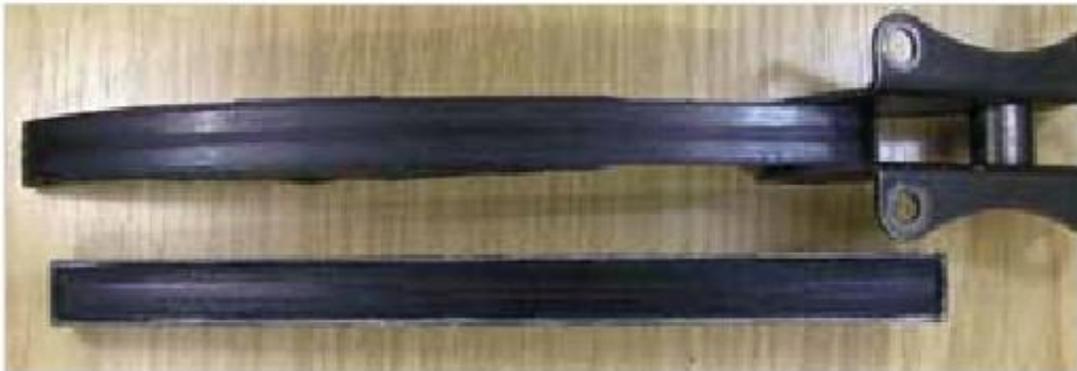
Figure 7-1: Sliding surfaces of the timing chain tensioning rail

In the Figure 7-1, the front and rear Kettengleitschiene in heavily worn state shown.

A stretched timing chain tends to loose for striking, while a very low-to stretched timing chain to large forces the sliding surfaces of the slide rails and The ball joint exercises, leading to similar Chen claims resulting images, as in the See Figures 7-1 to 7-5.

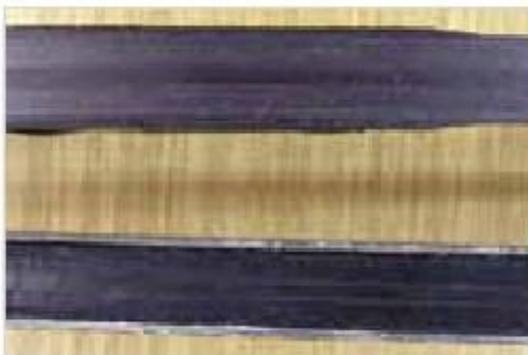
Figure 7-2: enlarged view of the sliding surfaces

Figures 7-2 and 7-3 show the Wear pattern in detail. The figure 7-3 shows that on the back of the back-Teren timing chain tensioning rail in front-existing spherical cap, in which the tax erkettenspanner intervenes. Excessive Wear on the cam chain tensioning and seemed to control the chain itself occurs both in bulk and to contribute to tightened control chain.

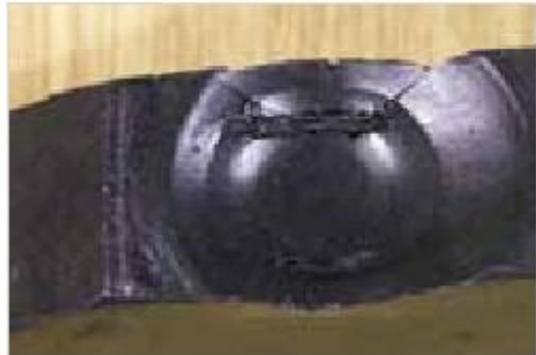
Figure 7-3: Spherical cap of the pressure bar the timing chain tensioner

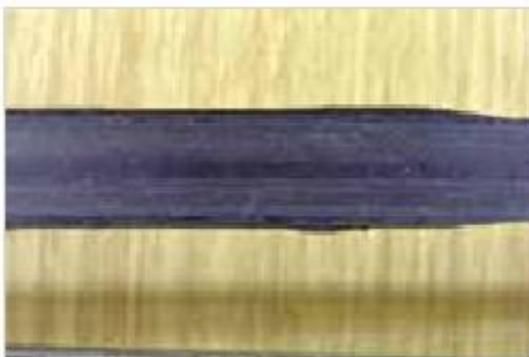
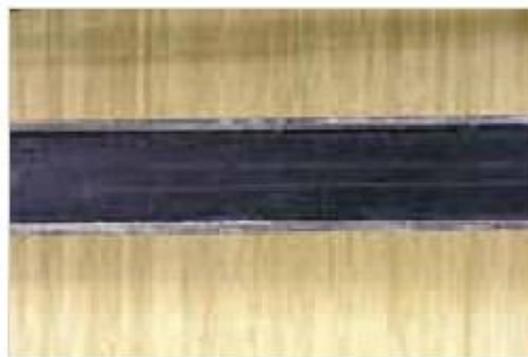
Figure 7-4: Wear of sliding surfaces in the image detail

Figure 7-5: Wear of sliding surfaces in the image detail

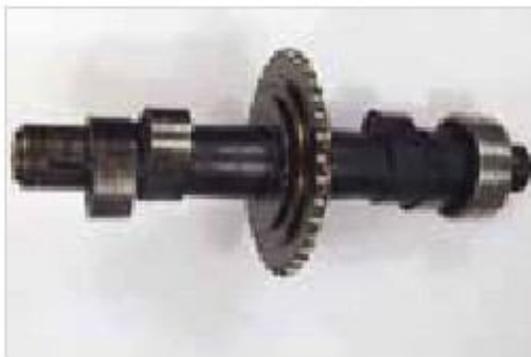
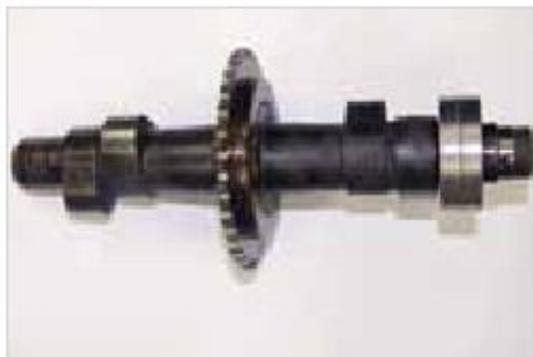
Figures on a 7-6 to 7-9 Camshaft to see whose cams due to lack of oil from excessive Heat generation have been run. The corresponding sliding surfaces of a Rocker arm is in the pictures 7-10 and 7-11 mapped.

Figure 7-6: Camshaft with oil due to lack worn cam.

Figure 7-7: Camshaft with oil due to lack worn out cams

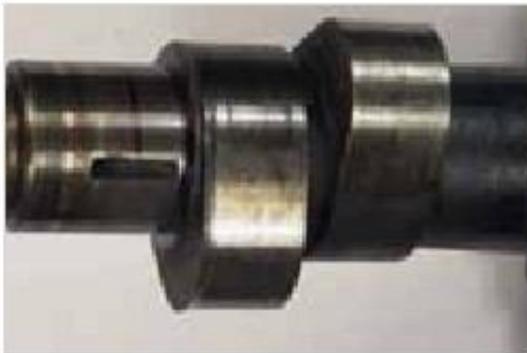
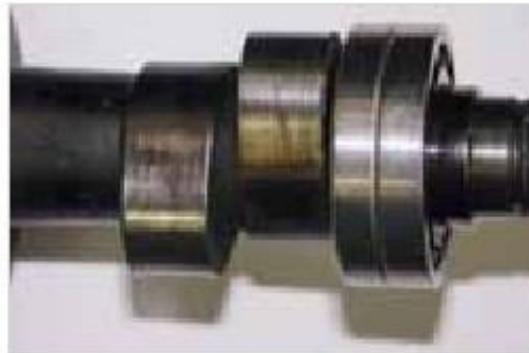
Figure 7-8: Worn cam in detail

Figure 7-9: Worn cam in detail

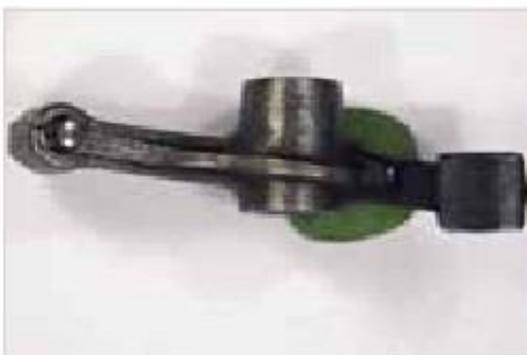
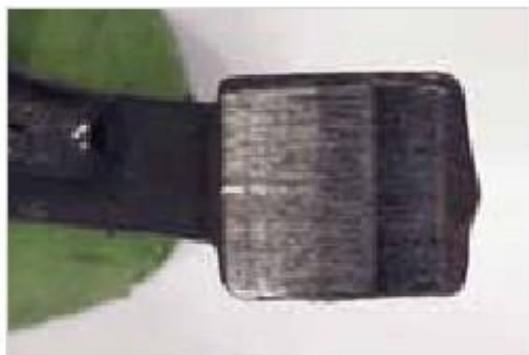
Figure 7-10: Associated sliding surface of a rocker arm

Figure 7-11: Associated sliding surface of a rocker arm

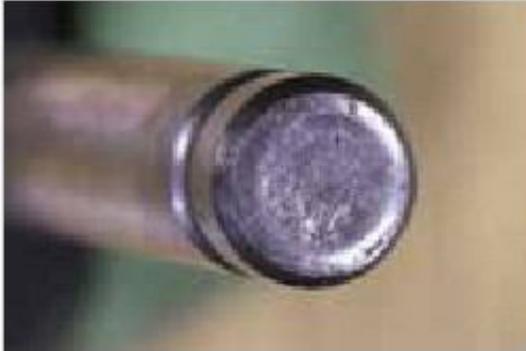
One major drawback to valve clearance is addition to a low power loss (Because the valve does not go far enough opens), the rocker with the A-ing screw later after a larger Ren idle stroke - and thus faster - On the face of the valve stem meets. It works in the setting screw (Figure 7-13) in the end face-surface of the valve stem (Figure 7-12) one.

Figure 7-12: Face of the valve stem

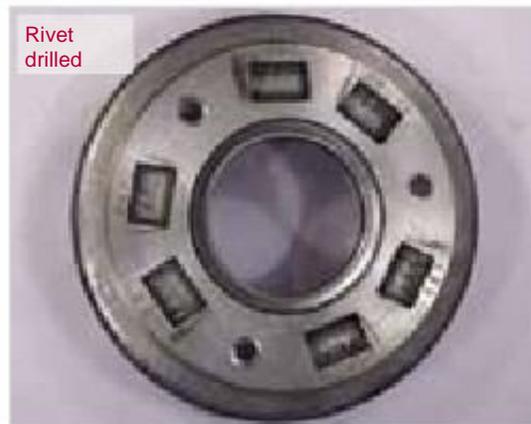
and again at discharge expan- . NEN Both the springs and their Runs in the clutch basket for this charge is not selected properly, so that break the springs and in the Clutch basket to incorporate.

Figure 7-15: Back of the clutch basket with degraded shock absorber springs

Springs with a larger wire diameter bring this situation, however, have different-reinforced shock absorber springs and a GE-ring protection effect for the transmission.

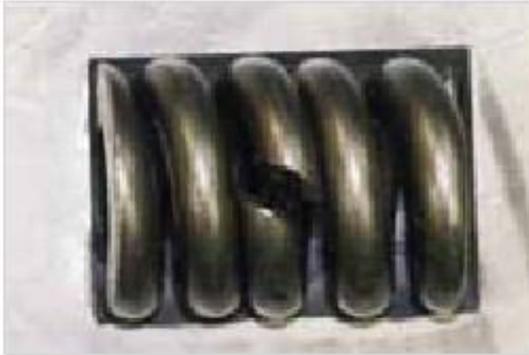
Figure 7-16: Broken damper spring

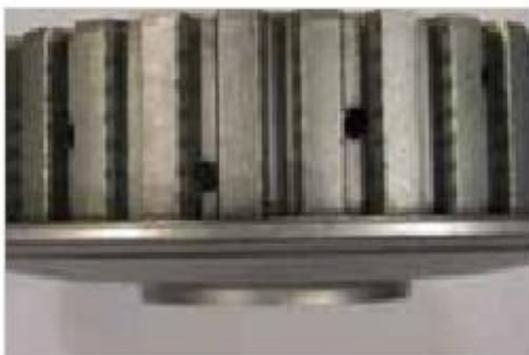
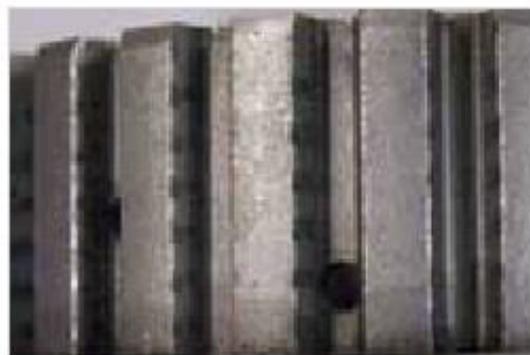
Both the friction plates as the interposed plate washers are working with their edges in the respective grooves of the inner and An outer part of the clutch basket. The Figures 7-18 and 7-19 show the Imprints of plate glass in the Nu-th of the inner part of the clutch basket.

Figure 7-18: Inner clutch basket with Prints the sheet metal discs

Figure 7-19: Inner clutch basket with imprints of Metal discs (enlarged detail)

Reworking is not normally necessary because the clutch despite the ex-pressures still separates, which only slightly slower is because of the cones Clutch discs on the prints must not slip. They should each but deliberately turn slowly, so the clutch when changing gears also is completely separated, otherwise compo- of the gear are damaged.

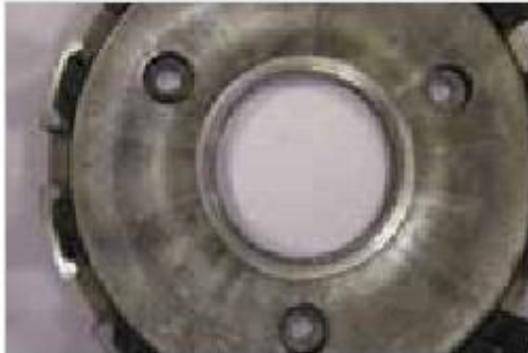
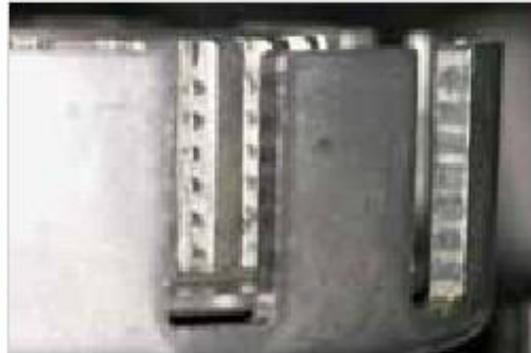
In the illustrations are 7-20 and 7-21 the grooves of the outer part of the clutch basket with the imprints of the edges of Clutch shown. Off-Figure 7-22 shows a Detailvergröße-tion of the prints.

Figure 7-20: Grooves of the outer clutch basket

Figure 7-21: Impressions of the friction in the grooves the outer clutch basket

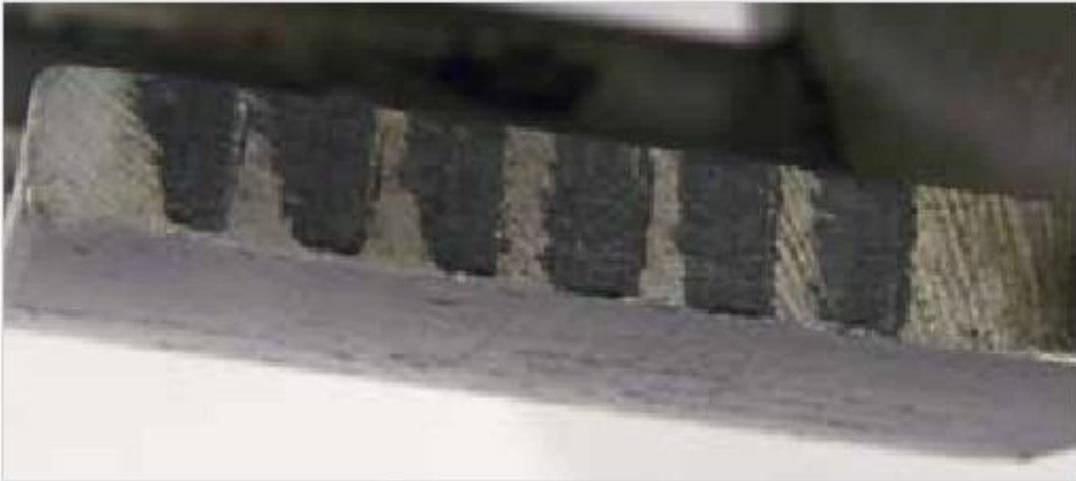
Figure 7-22: Impressions of the friction in the grooves of the outer clutch basket (enlarged detail)

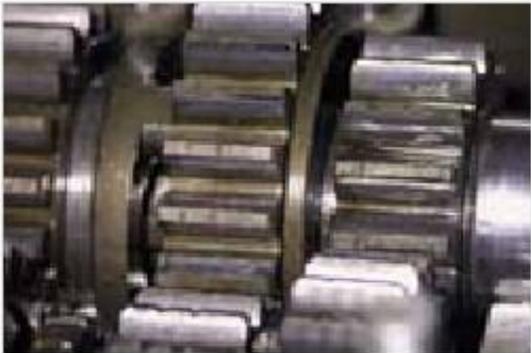
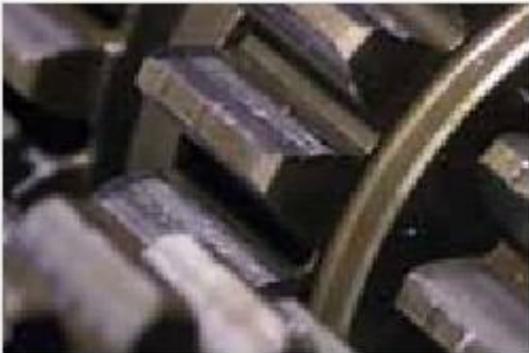
Figures 7-23 and 7-24 show Tooth flanks of a gear with a mileage of about 260,000 to 270,000 km with heavy pitting on the tooth flanks. The pitting was the change of the ball bearing

Figure 7-23: Pitting on the tooth flanks

Figure 7-24: Pitting on the tooth flanks

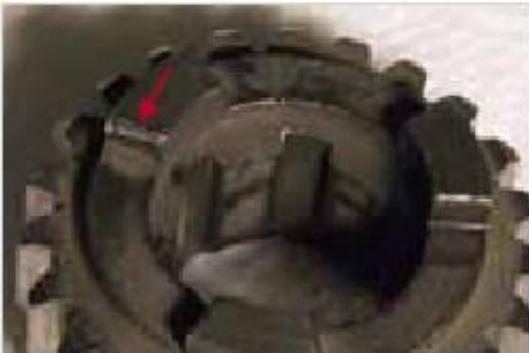
The worn teeth shift clutches of the of the fourth gear wheel (fig. 7-26) and the well worn edges of the Nu- th in the gear of first gear mach- th through the loud rattling noticeable first gear so that the first- te response was no longer usable. The Areas where the puck still wear are greatly reduced, so that a Such damage to progress quickly is. Gear wheels on their Schaltklau- s or its counterpart, the grooves, already wear is visible, should no longer be used, as well The shift forks affected pulled- are gene.

Figure 7-26: Gear of the fourth gear on the transmission output shaft

The shift dogs are not thus far enough into the correspond- the slots of the mating gear pushed so that the area needed to power transition is available, little is and thus rounding off the edges of the Shift dogs is accompanied, as on the ex- Figure 7-26 in advanced stages, to see.

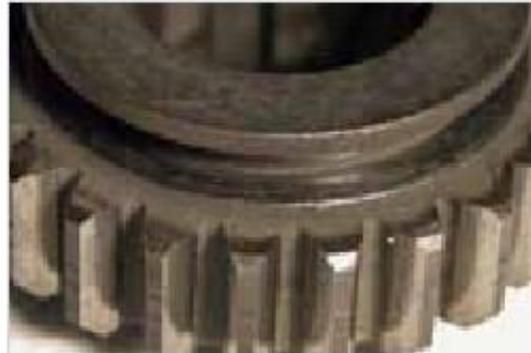
Figure 7-28: Gear of the fourth gear on the transmission output shaft

The force that through the "Skip"
Claw of the switch has caused, at
the shift forks and circulate in the
the grooves caused an abrasion, the
shown in detail in the Figure 7-28
is.

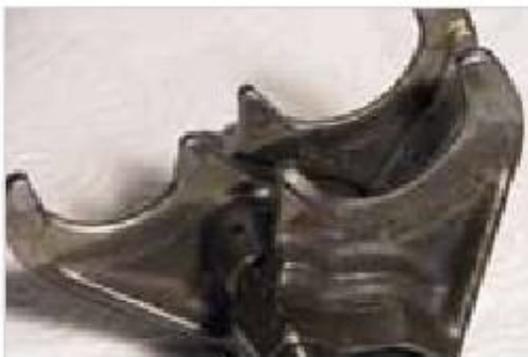
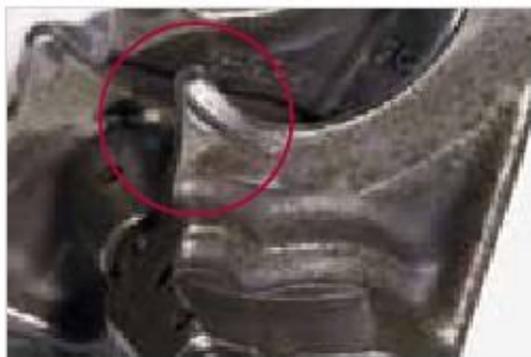
A similar material to abrasion,
the circumferential grooves also arises
at the ends of the shift forks, which in
engage the circumferential grooves. The
Consequence is that the end of the shift fork
is narrower, while the circumferential
concerned grooves widen.

Figure 7-29: Shift forks

Figure 7-30: Shift fork for shifting the first Ganges with material abrasion on the ends

An appearance of the shift fork for switching times of the first passage, as the ex- 7-29 and 7-30 formations documented is another consequence. Shift forks, the at the ends of an incipient Ver- wear should have, at no Case be used, although there- first with a perfect switch will be possible. But because the switching steal no longer able to bear right since this is not far enough into the Project into the grooves of the opposite wheel, so that a sufficiently large area for Power transmission is available, it is premature to the here-documented oriented type of damage occur.

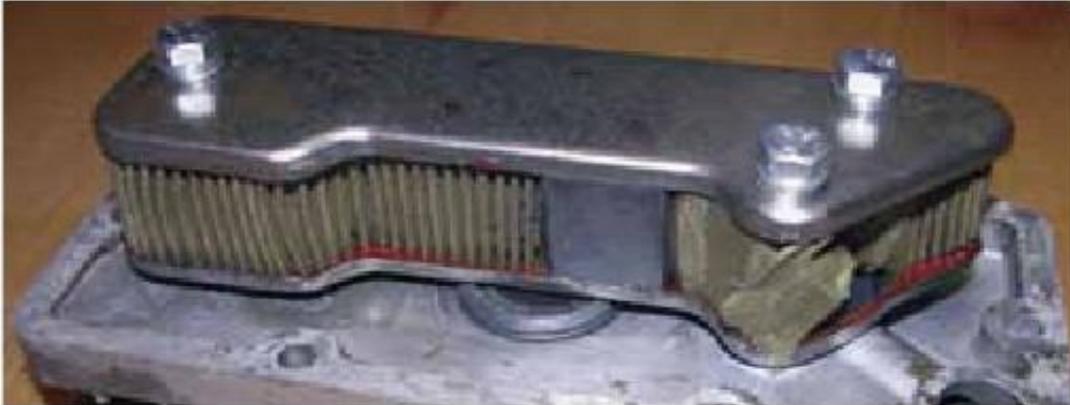
Figure 7-31: Oil filter with filter eingerissenem.

The filter screen of the original oil filter which is at the lowest point of the Mon- torgehäuses below the crankshaft is a tendency, after a short tongue useful life to tearing, as this shown on the Figure 7-31 is. It there is the possibility of such oil filter repair and by attaching to prevent a baffle that the filter material to tear again. To recom- is missing, however, such a repair Nevertheless, since the filter material to is a coarse mesh to fine metal particles cles, especially during the rolling of the Teeth of the gears caused so effectively filter out that this oil pump can not hurt.

There are internal filter paper offered, the filter cartridge out- can be exchanged. The disadvantage here is that the filter changes the Sumpfil- circuit boards must be dismantled. Then is there a conversion to a außenlie- following filter cartridge, such as those for car Engines is common. Here, however, the limited ground clearance.

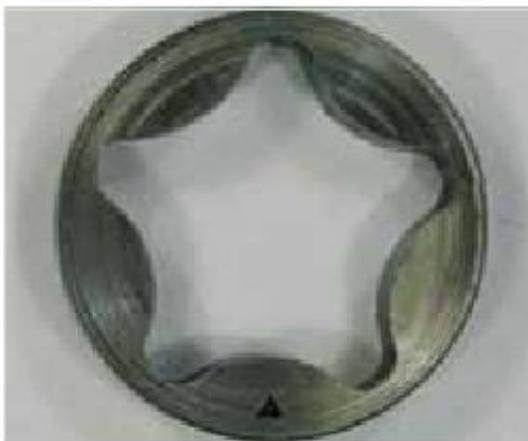
Figure 7-32 is on a much different- CLOSE outer rotor to see. The Oil pump worn by metal debris, which is not filtered from the oil filter. Promotes with increasing wear the oil pump less and less oil, which again increased wear on other Components of the engine and transmission has more abrasion result.

Figure 7-32: Outer rotor of oil pump

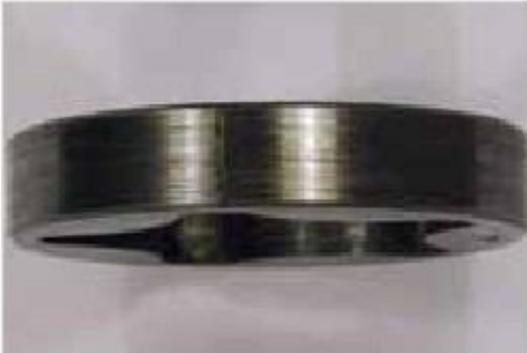
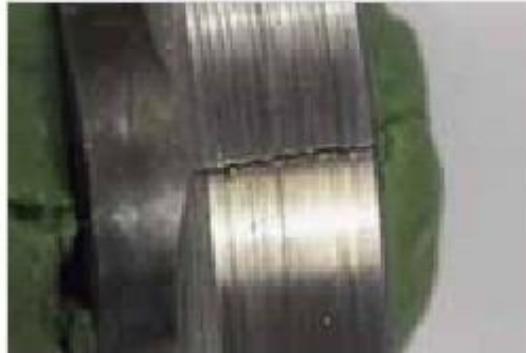
Looks at the figures 7-34 and 7-35 to an outer rotor with a Crack that is not filtered by a Foreign body was created.

Figure 7-34: Outer part of the oil pump with crack

Figure 7-35: Outer part of the oil pump with a plan (details)
