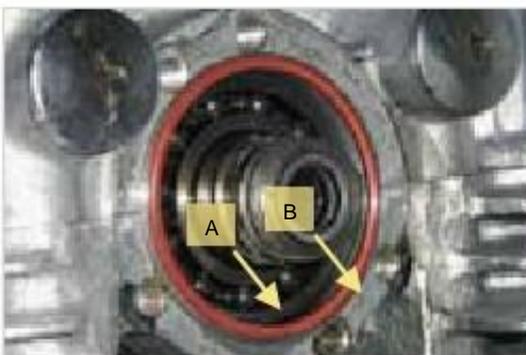
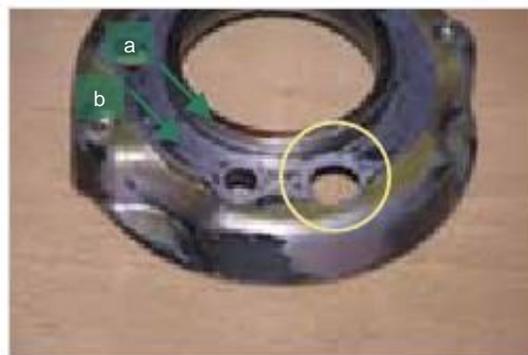
If the distance between the surfaces "A" and "B" is not greater than the distance between the surfaces "a" and "b", so is not pressed, the paper seal but the area "a" is pressed onto the surfaces,

che "A" if the mounting screws be tightened. Between the surfaces-Chen, "b" and "B" is then a gap, the correct seal is prevented.

If the mounting screws to attracting fixed, it can lead to damage how come within the Kreismarking on image to see 6-139. For the the screw head countersunk area then breaks out of the case, as in Detail in the images 6-141 and 6-142 to see.

Figure 6-138: Measure the distance between the surfaces Figure 6-139: Measure the distance between the surfaces

Before the housing for the centrifugal regulator and the breaker plate are installed, check if the no-ckenwellenlager deep enough in the case the cylinder head are positioned. To this end we measure with calipers with depth to the distance between the yellow arrows on the screen 6-138 -marked "A" and "B". To the determined amount is added to the Thickness of a paper seal of approximately 0.5 mm.

The result must be greater than the Distance between the green with the Arrow-marked "a" and "b" in Figure 6-139, the one on the same type using a caliper with tie-fenmaß measures.

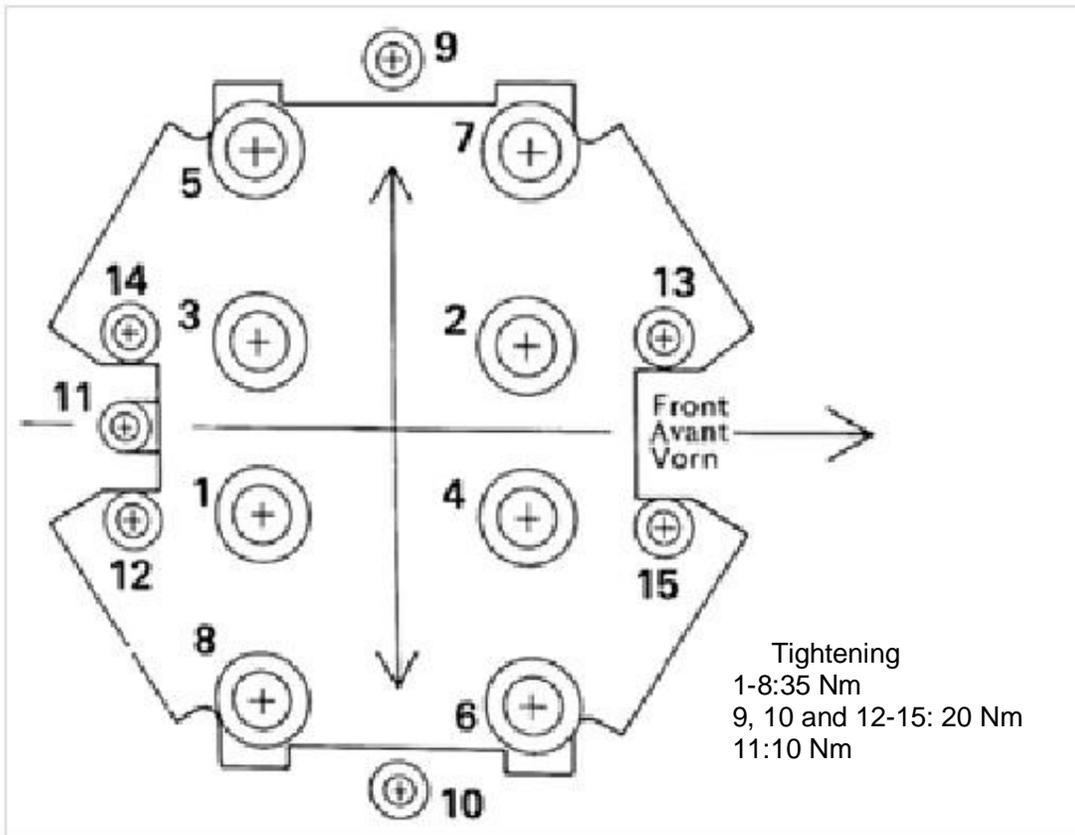
Figure 6-140: Tightening Torques and

The cylinder head bolts must - As with the dismantling - in the order sequence as shown in Figure 6-140, be tightened. In principle, by attracted inside to the outside, to-only the - stable - M 10 x 1.5 nuts be tightened and then the M 8 Screws.

The cylinder head bolts must be tightened in order.

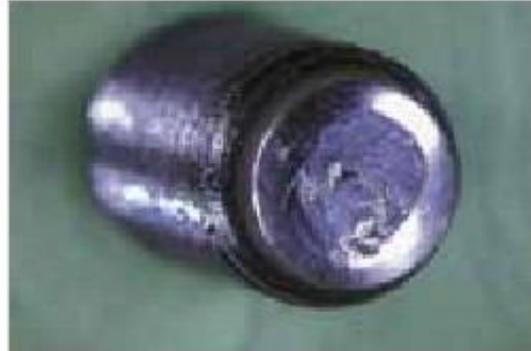
One major drawback to valve clearance is addition to a low power loss (Because the valve does not go far enough opens), the rocker with the A-ing screw later after a larger Ren idle stroke - and thus faster - On the face of the valve stem meets. It works in the setting screw (Figure 7-13) in the end face-surface of the valve stem (Figure 7-12) one.

Figure 7-13: Associated surface of the screw

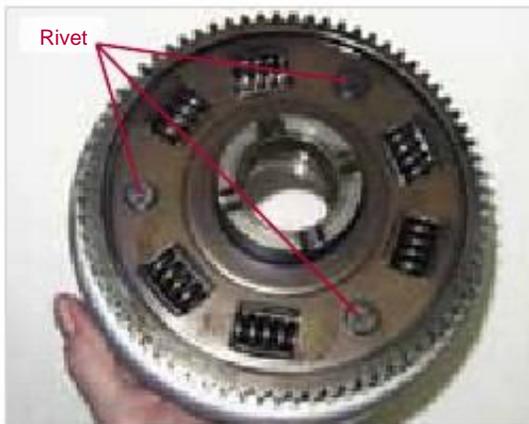
Figure 7-14 shows the inner part of the Clutch basket with attached tooth- rad of the primary drive and the mapping 7-15, the outer part of the clutch basket mined from the back with jerk . damper springs In the illustrations 7-16 and 7-17 are a broken Shock absorber spring and the associated

Figure 7-14: with the primary drive gear mounted

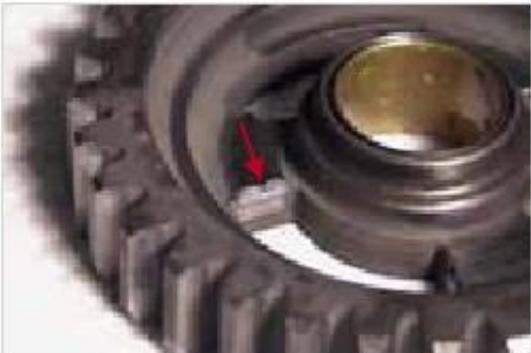
The worn teeth shift clutches of the of the fourth gear wheel (fig. 7-26) and the well worn edges of the Nu- th in the gear of first gear mach- th through the loud rattling noticeable first gear so that the first- te response was no longer usable. The Areas where the puck still wear are greatly reduced, so that a Such damage to progress quickly is. Gear wheels on their Schaltklau- s or its counterpart, the grooves, already wear is visible, should no longer be used, as well The shift forks affected pulled- are gene.

Figure 7-25: Gear of first gear on the transmission output shaft

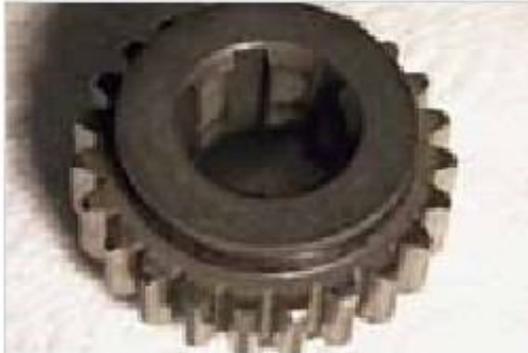
Figure 7-27: Gear of the fourth gear on the transmission output shaft

The gear wheels are of the
Turn selector forks for the individual
NEN passages in the axial direction on the
Transmission shafts moved. They have
circumferential grooves in the Schaltga-
Belnem intervene. Figure 7-27 shows the
Gear of the fourth gear on the Ge-
gearbox output shaft, which Schaltklau-
s can be seen on the Figure 7-26.

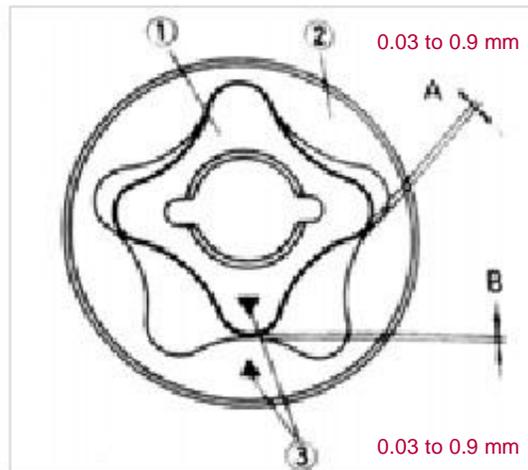
Figure 7-32 is on a much different- CLOSE outer rotor to see. The Oil pump worn by metal debris, which is not filtered from the oil filter. Promotes with increasing wear the oil pump less and less oil, which again increased wear on other Components of the engine and transmission has more abrasion result.

Figure 7-33: Wear dimensions of the outer rotor
