Photos: First Images of the Lost Russian Cruiser Moskva Emerge

PUBLISHED APR 17, 2022 8:09 PM BY [THE MARITIME EXECUTIVE](#)

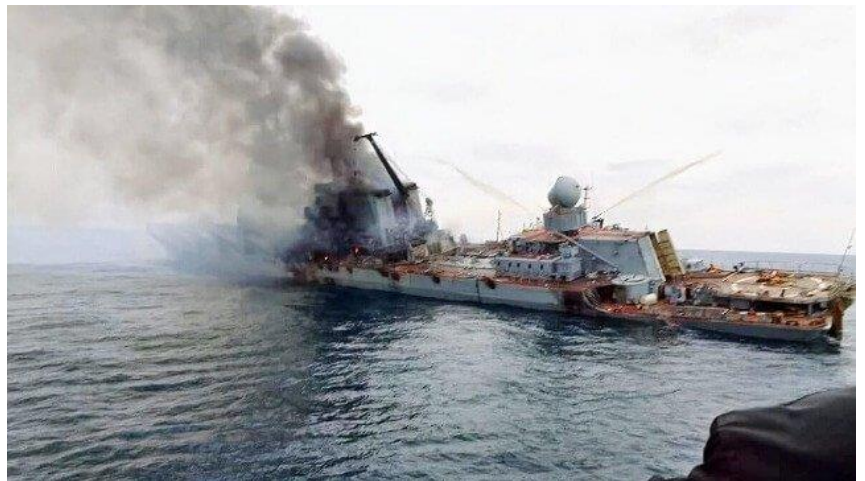
Purported image of Moskva on her final day afloat. Analysts suggest that the image is consistent with the vessel's configuration and Ukrainian accounts of the strike (Unknown source)

If verified, the photos appear consistent with an anti-ship missile strike, according to independent open-source analysts. The most detailed image (top) appears to show two holes amidships at the waterline, just below the stacks on the port side. Significant fire damage is visible above decks, and the ship has a pronounced list to port. Black smoke marks at multiple hull penetrations near the main deck level are consistent with an internal fire running aft of the site of impact, according to analysts.

According to analyst H.I. Sutton and others, the two streams of water visible behind the cruiser may be from the monitors of a firefighting tug, which may be hidden from view by the *Moskva*'s hangar structure aft.

The weather and surface conditions appear to be mild, contrary to official Russian accounts of the loss, and the cruiser does not appear to be making way under tow. Her life rafts are missing, suggesting an evacuation had already been conducted at the time the images were taken.

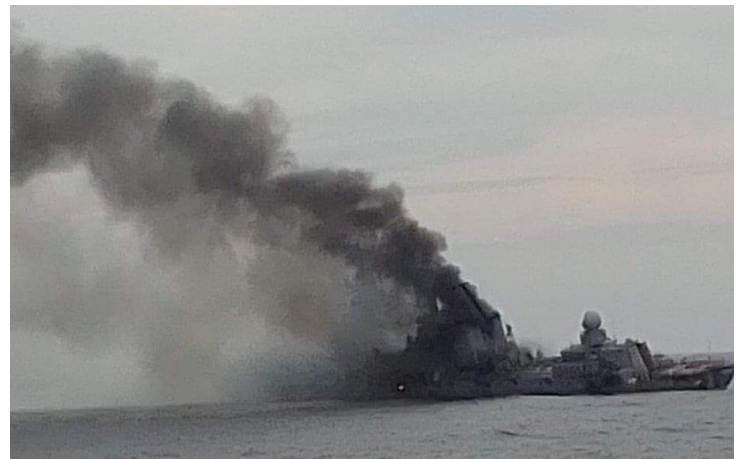
After the attack (Source unknown)
